# Field Performance of Structural Concrete Slabs Containing an Hydrophobic Admixture

D. Cusson<sup>1</sup>, T. Hoogeveen<sup>1</sup>, R. Glazer<sup>1</sup>, A. Wiseman<sup>2</sup>

<sup>1</sup> National Research Council Canada, Ottawa, Canada

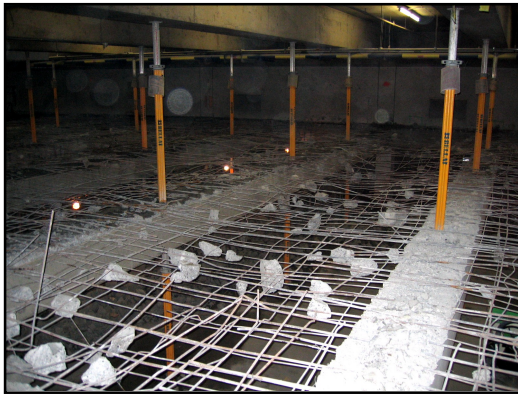
Figure 1a: Slab during demolition (before removal of reinforcement)

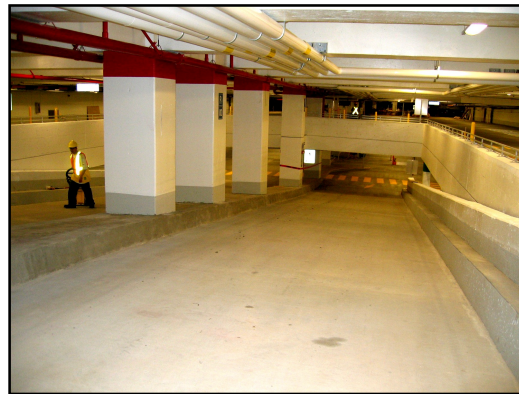
Figure 1b: Ramp after reconstruction

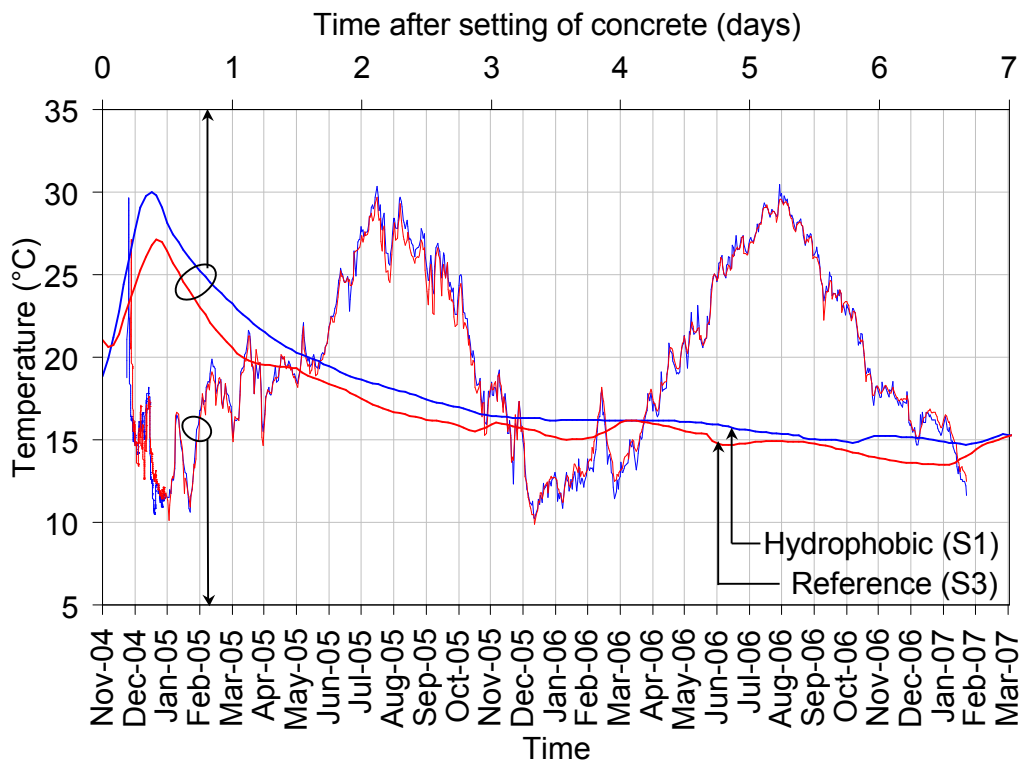
Figure 4: Measured concrete temperature

Figure 4 shows that the first 12 hours were marked by a moderate increase in temperature due to the heat released by cement hydration, followed by a cooling period. No major differences in temperature can be observed between the two types of concrete. In the long term, the concrete temperature followed a typical seasonal pattern, from 10°C in the winter to 30°C in the summer. Note that heating and air conditioning in this indoor parking structure maintained reasonable ambient temperatures.

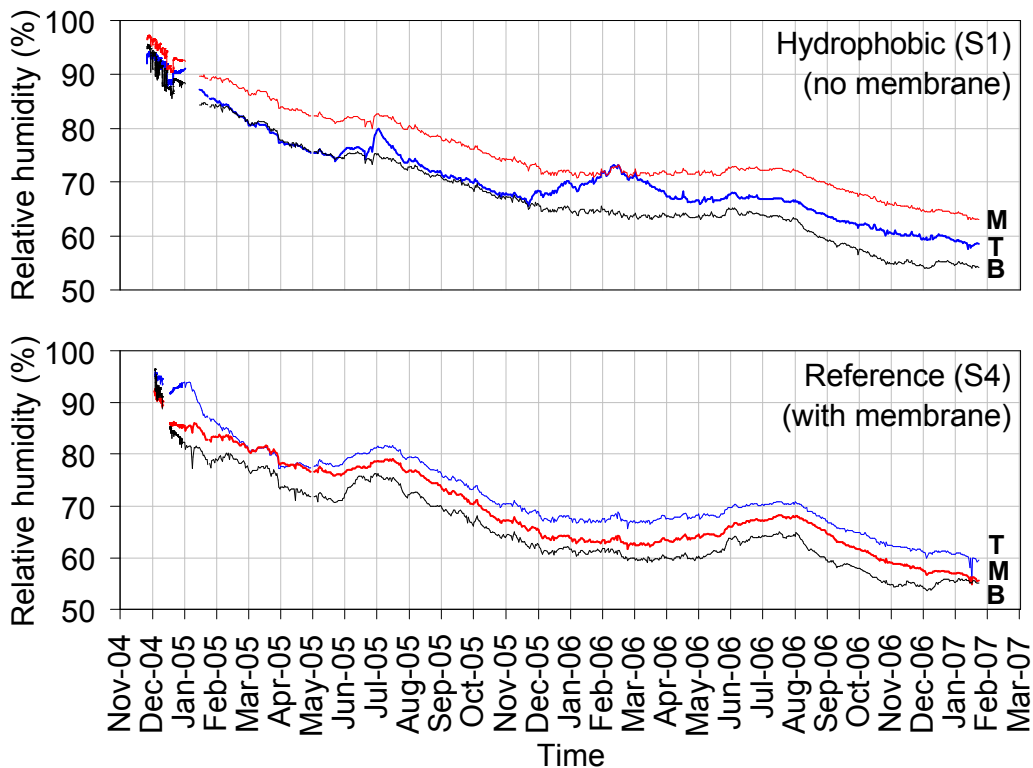
Figure 5: Measured concrete relative humidity

Figure 5 presents the RH measured in Sections 1 and 4 at different depths, i.e. at 45 mm from the top slab surface (T), at mid-depth (M) and at 45 mm from the bottom slab surface (B). It can be observed that the drying profile of the hydrophobic concrete slab is typical of slabs with two exposed surfaces, with the RH being higher at mid-depth than at the top and bottom surfaces at any given time. The drying profile of the reference concrete slab is typical of slabs drying from the bottom surface only, with lower RH at the bottom of the slab than at mid-depth and the top surface where the membrane is installed. The hydrophobic concrete slab seems to be less sensitive to ambient RH fluctuations than the reference concrete slab (see peaks in July 2005 and July 2006). This characteristic of the hydrophobic concrete may be inherent to its hydrophobic nature, however, both types of concrete reached relatively low values of RH below 60% after two years of drying. Shortly, the RH will most likely decrease below 50% in both types of concrete, at which level the risk of reinforcement corrosion can be considered low in uncracked concrete [2].

A difference of approximately 10% RH across the depth of the concrete slabs was found at any given time. This non-uniform drying profile may result in differential shrinkage cracking at the surface due to the self-restraint caused by the more pronounced drying at the exposed surface than at mid-depth or the unexposed surface. With regard to reinforcement corrosion, this cracking may be more problematic for the hydrophobic concrete slab with the top surface exposed (no membrane).

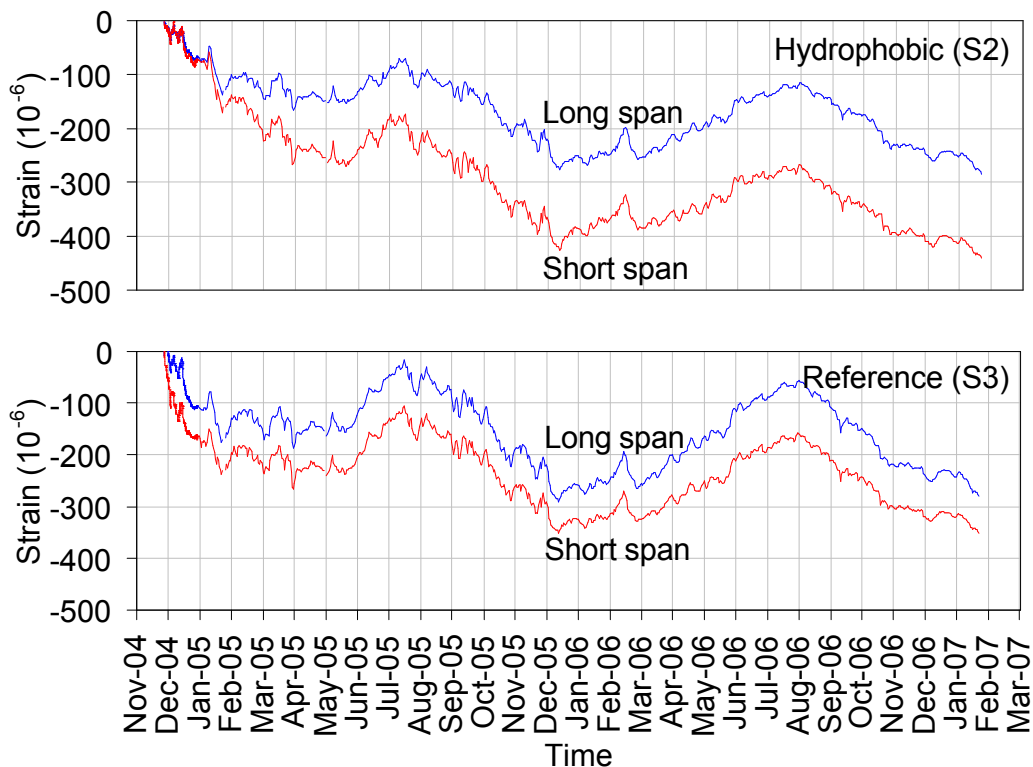
Figure 6: Measured concrete total strain

Figure 6 illustrates the total strain (incl. the shrinkage and thermal components) measured at mid-depth in Sections 2 and 3 along the short and long span directions. It can be observed that the total strain in the short span direction is always larger than in the long span direction. This is due to the lower stiffness of the girder/floor system in the short span direction than in the long span direction, resulting in a larger component of free shrinkage. Over time, both types of concrete reached similar levels of total strain.

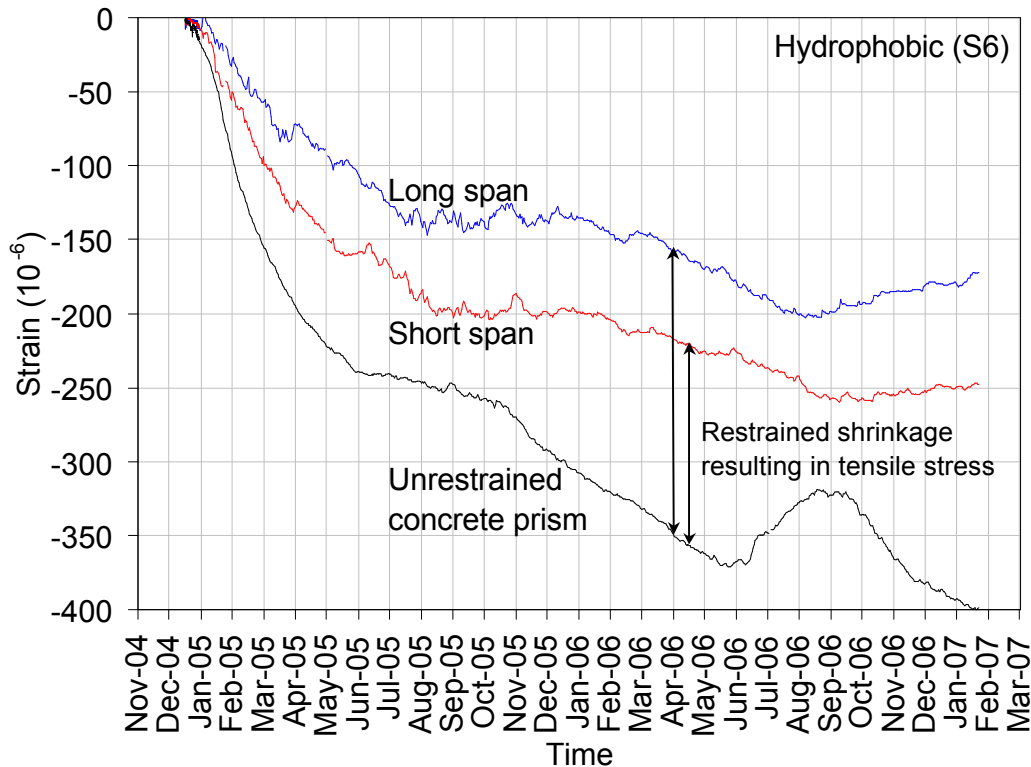
Figure 7: Calculated net shrinkage strain

Figure 7 presents the calculated net shrinkage strain (i.e. thermal strain component removed) in the hydrophobic concrete ramp (Section 6) along the short and long span directions, as well as the net shrinkage strain in the corresponding unrestrained hydrophobic concrete prism. Assuming

that the in-situ concrete in Section 6 is subjected to similar environmental conditions as the concrete in the unrestrained prism, their shrinkage strain curves can be compared to estimate the tensile stresses generated in the in-situ test sections. For any given time, the elastic tensile stress will be proportional to the amount of restrained shrinkage strain, which can be calculated as the difference between the in-situ shrinkage strain (measured under partial restraint) and the shrinkage strain in the concrete prism (measured under free shrinkage).

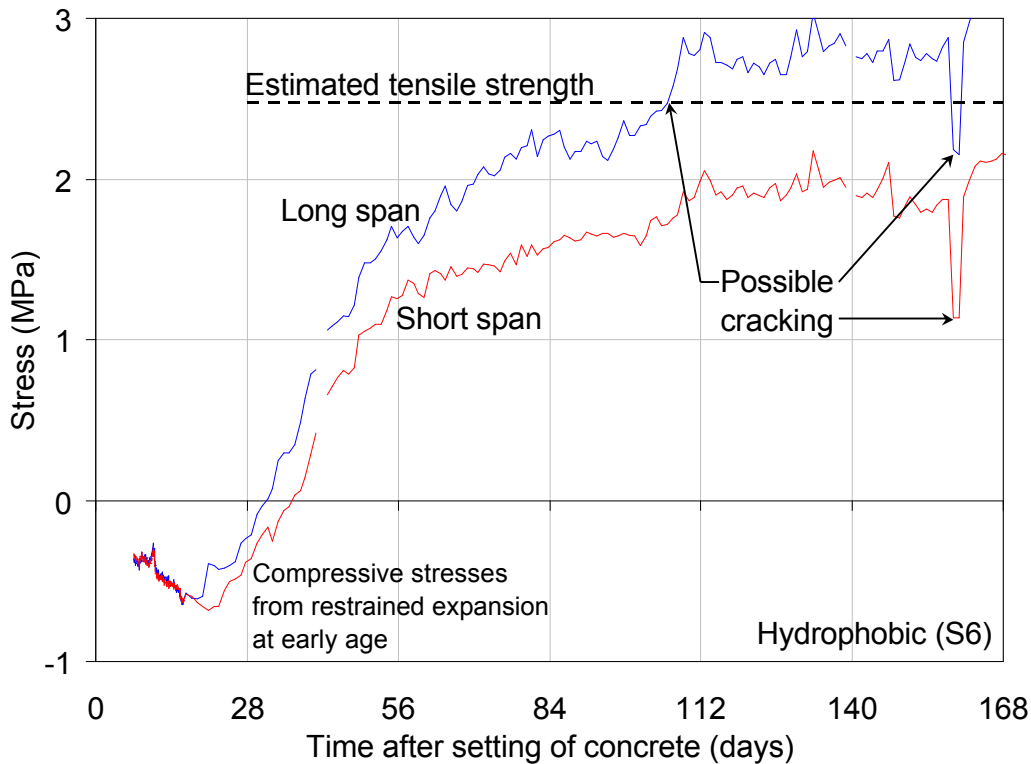
Figure 8: Calculated concrete stress

For the hydrophobic concrete ramp (Section 6), Figure 8 presents the calculated tensile stress developing in both directions for the first 6 months. The tensile stress in the long span direction was quite significant and reached the tensile strength after nearly 4 months.

The stress results calculated for all six sections were used to determine whether the concrete near the strain gauges had cracked or not. Cracking occurred in all test sections regardless of the type of concrete used. The cracks were detected either within the gauge length (e.g. sudden increase in strain, resulting in stress reaching the estimated tensile strength) or near the strain gauge (e.g. sudden decrease in strain and tensile stress, due to energy release after cracking). Visual inspections confirmed the cracking in all test sections.

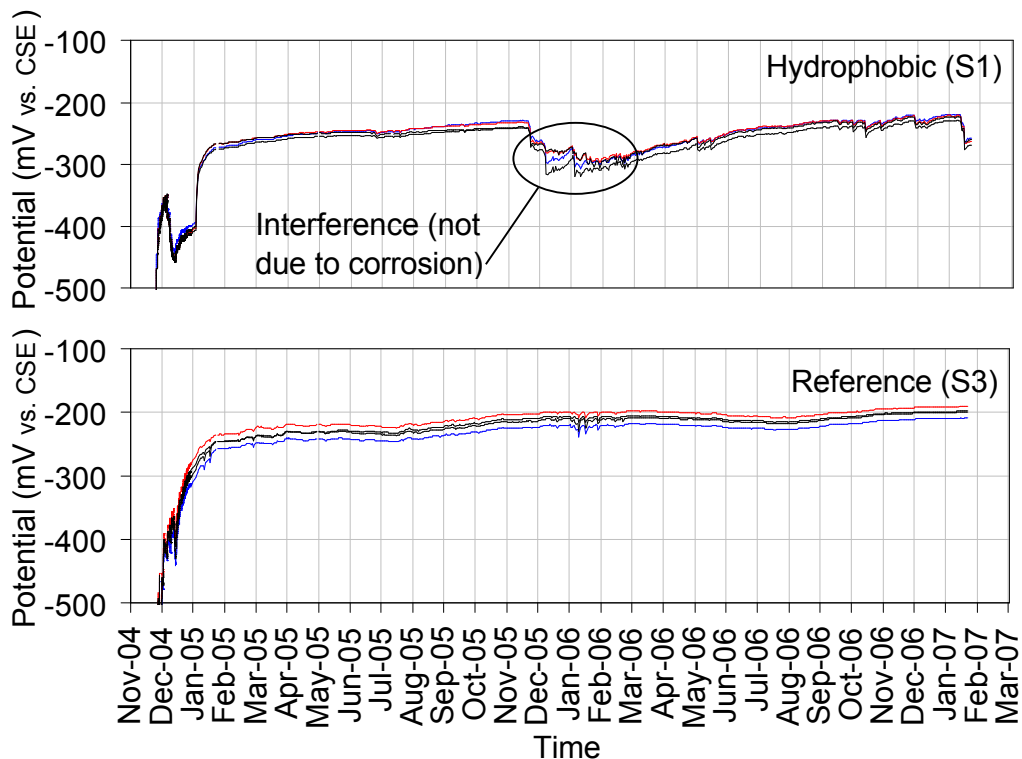
Figure 9: Measured corrosion potential of steel reinforcement

Figure 9 illustrates the corrosion potential of the reinforcement measured by the embedded reference electrodes in Sections 1 and 3. Note that the electrodes were evenly distributed along the top and bottom reinforcement. Within each test section, very little difference in corrosion potential is observed between the units, locations or depths in concrete. It can also be observed that a two-month period was required for the electrodes to reach equilibrium with the surrounding concrete, which is normal. After the initial period, stable potentials between  $-200$  and  $-250$  mV vs. CSE were reached in both types of concrete, which are indicative of a low risk of corrosion of the reinforcement according to ASTM C876 [5]. This is to be expected in a newly rehabilitated parking structure.
