Deterioration of portland-metakaolin cement pastes and mortars exposed to magnesium sulfate solution

Abstract: This paper describes the deterioration degree and chemical resistance of Portland-metakaolin cement pastes and mortars exposed to 4.24% magnesium sulfate solution. Both pastes and mortars, which were prepared using a water-binder ratio of 0.45, were exposed to magnesium sulfate attack. The main variable was the level of cement replacement (0 to 15% by mass) by metakaolin.

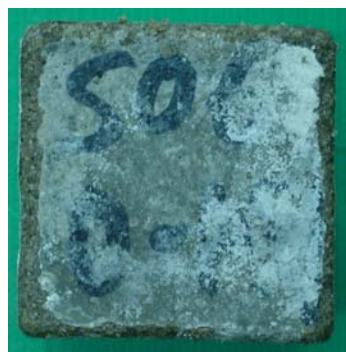
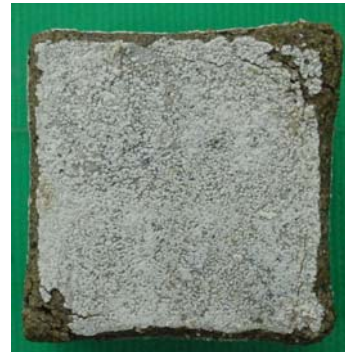
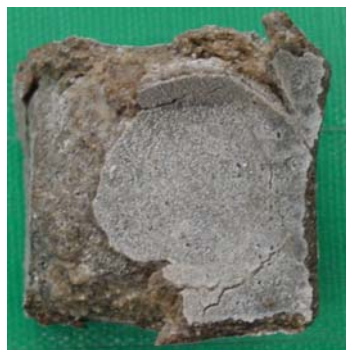
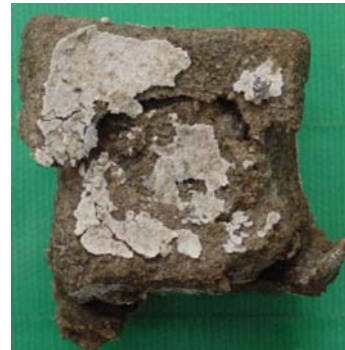
All the mortar cubes were carefully examined at regular intervals to monitor for visible signs of cracking and damage suffered under magnesium sulfate attack. Fig. 1 shows the visual appearances of mortar cubes with different replacement levels of MK exposed to magnesium sulfate solution for 720 days. This makes it clear that the degree of deterioration was significantly different with the replacement level of MK. In particular, for the mortar cubes with 15% MK cement replacement by mass (Fig. 1 (d)), exhibited the worst performance with a great amount of cracking and spalling as well as delamination. In fact, the deterioration of the mortar cubes started at as early as 91 days. As the deterioration progressed, the mass loss of the specimens was severe and they completely disintegrated after 720 days as shown in Fig. 1.

Fig. 1 Visual appearance of mortars exposed to sulfate attack

The expansion-exposure time relationship of mortar bars obtained in accordance with ASTM C 1012 test method is given in Fig. 4. The expansion of mortar specimens with 15% MK was 0.556% after 360 days of exposure, compared with a value of 0.244% noted in mortar specimen without MK. It should be noted that the mortar specimens containing 10 and 15% MK had disintegrated after 420 days of exposure, although the mortar specimen without MK expanded only 0.418% after that exposure period, but was disintegrated after 540 days of exposure. It was obvious that the higher replacement level of MK led to the higher expansion in mortar mixture. This trend is in agreement with the visual appearance ratings shown in Fig. 1.

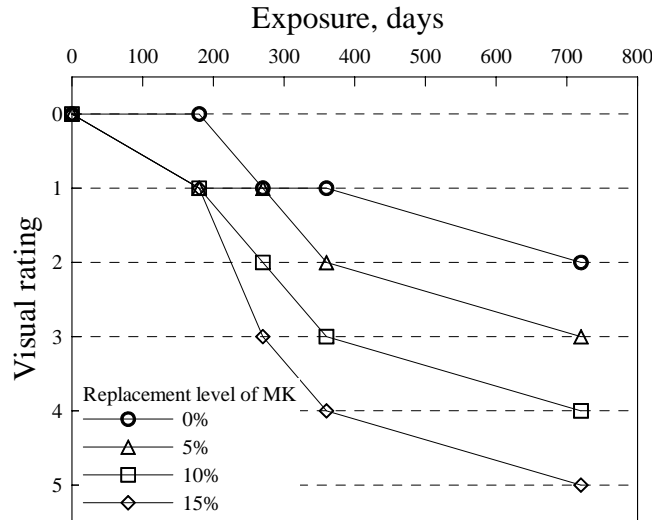
To detail the progress of deterioration, the visual rating of mortar cubes based on the study by Al-Amoudi [9] was used and the results are shown in Fig. 2.

Fig. 2 Visual rating of mortar cubes

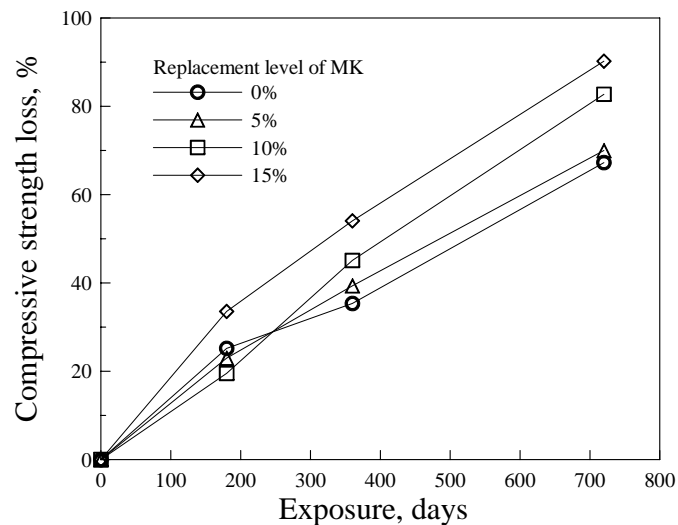
The compressive strength loss of mortars with and without MK immersed in magnesium sulfate solution was compared with those cured in tap water is shown in Fig. 3. The results indicate that the compressive strength loss of mortar specimens with increasing replacement level of MK increased after 360 days of exposure. The overall strength loss is associated with the replacement levels of MK. In particular, mortar specimens with a higher replacement level of MK displayed poor performance with respect to compressive strength. After 720 days of exposure in magnesium sulfate solution, the compressive strength losses of mortar specimens with replacement levels of 0, 5, 10 and 15% were 67.3%, 70.0%, 82.7% and 90.2%, respectively.

Fig. 3 Compressive strength loss of mortar specimens

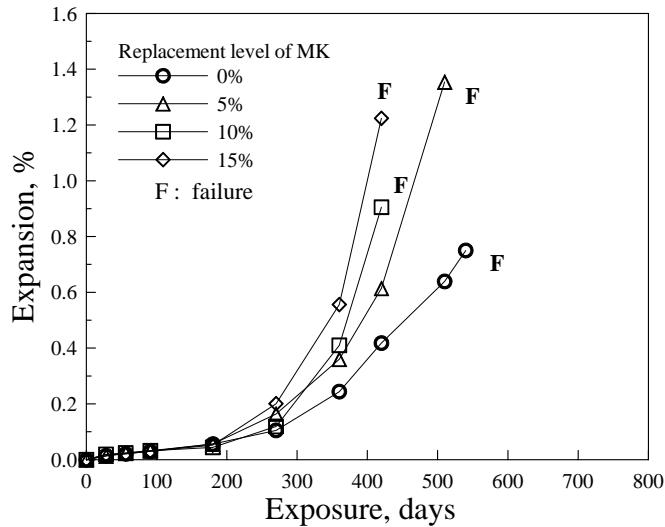
Fig. 4 Expansion of ASTM C 1012 mortar specimens

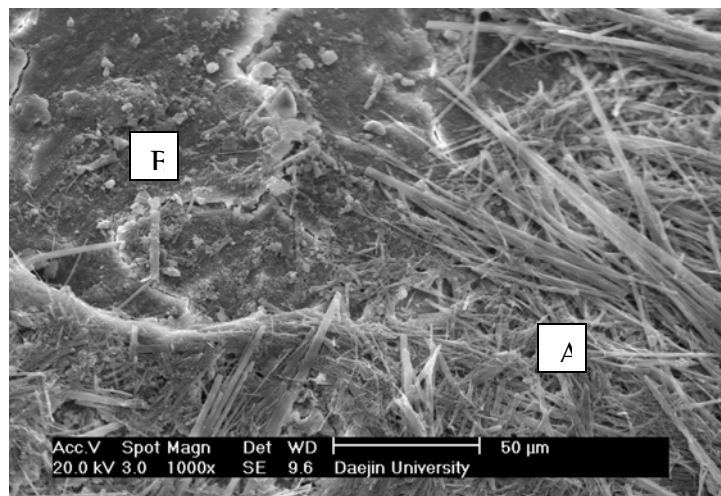
The microstructural features of the paste samples continuously immersed in the magnesium sulfate solution for 360 days were observed using SEM. To determine the reaction compounds formed in the paste samples due to magnesium sulfate attack, EDS analysis was also used. Because the mortar specimen containing 15% MK showed the most deterioration from the results of visual appearance, the microstructural observations for SEM and EDS analysis were focused on only the paste samples with 15% MK. Fig. 6 shows an SEM image on the surface of the paste sample with 15% MK which had deteriorated due to the magnesium sulfate attack. A great amount of reed-type products was observed in the right-hand side of the image. EDS analysis on these products (point A in Fig. 6) showed the

Fig. 6 SEM image of paste specimen with 15% MK exposed to magnesium sulfate solution for 360 days

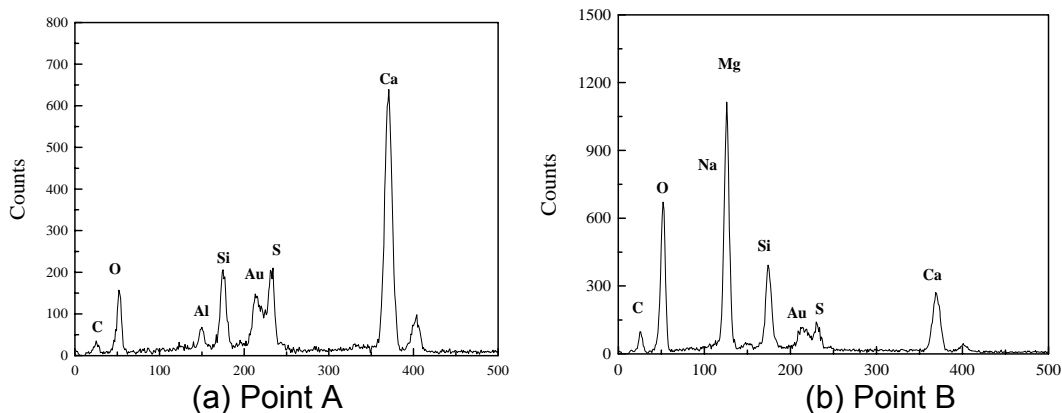
formation of thaumasite indicated by the presence of the calcium, sulfur, silicon and oxygen as well as a small amount of carbon as shown in Fig. 7 (a). Although there was a small amount of aluminum in the spectra, the product appeared to be thaumasite rather than ettringite. Fig. 7 (b) shows the EDS profile for the point B in Fig. 6. The presence of M-C-S-H (or Mg-rich C-S-H) due to the magnesium sulfate attack was confirmed through the EDS analysis. In fact, the product was not detected by XRD, because of its poor crystallinity.

Fig. 7. EDS profiles of Points A and B shown in Fig. 6

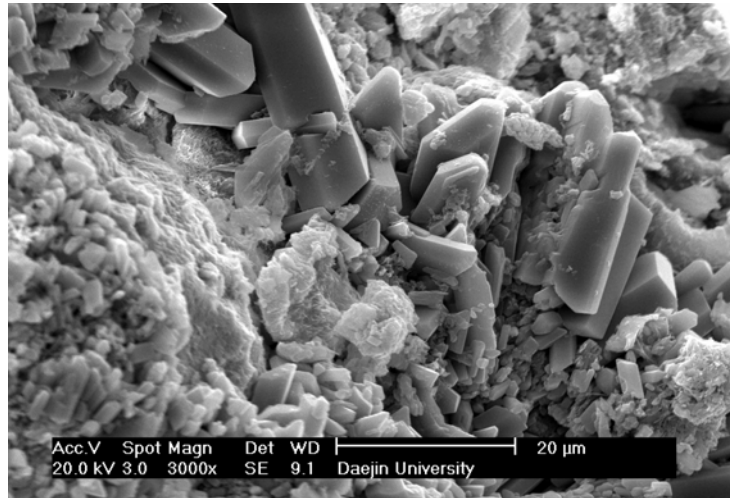
A different SEM image from the same sample is shown in Fig. 8. This image indicates the presence of subhedral gypsum in the deteriorated part of the paste sample.

Fig. 8 Different SEM image of the 15% MK paste specimen exposed to magnesium sulfate solution for 360 days

It seems that the primary cause of the severe deterioration of mortar specimen with MK is the formation of thaumasite and gypsum, but not the formation of ettringite.
