# Field Performance of Structural Concrete Slabs Containing an Hydrophobic Admixture

D. Cusson<sup>1</sup>, T. Hoogeveen<sup>1</sup>, R. Glazer<sup>1</sup>, A. Wiseman<sup>2</sup>

<sup>1</sup> National Research Council Canada, Ottawa, Canada

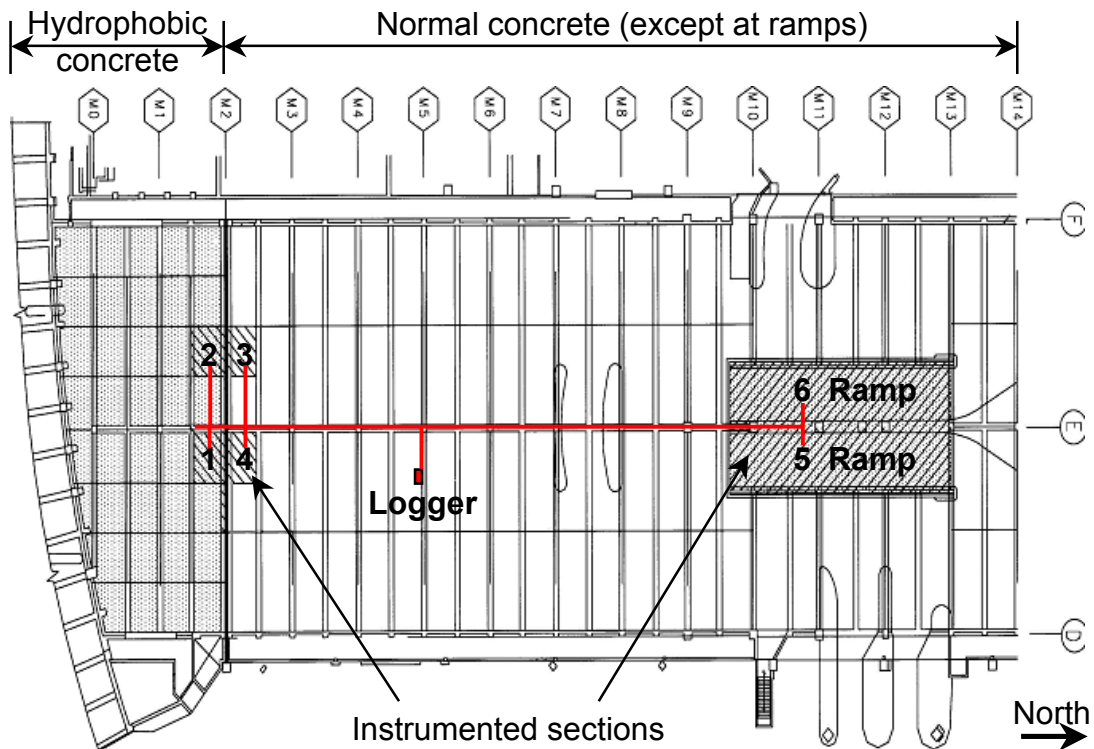
Figure 2: Plan view of parking structure floor

As shown in Fig. 2, four 150-mm thick sections of elevated concrete slab (Nos. 1 to 4) and two 250-mm thick concrete ramps (Nos. 5 and 6) were instrumented to evaluate their performance relative to shrinkage cracking and reinforcement corrosion. Two of the slab sections were built using hydrophobic concrete, and the remaining two were made of normal concrete and used as references for comparison. The reinforcing steel of the slabs consisted of two layers of 10M rebars spaced at 150 mm each way, with a concrete cover of 35 mm. Both ramps were built with hydrophobic concrete. The reinforcing steel of the ramps consisted of two layers of 15M rebars spaced at 150 mm each way, with a concrete cover of 45 mm.

In an effort to prevent restrained shrinkage cracking of the elevated concrete slabs, the concrete was placed in a checkerboard pattern. A 4 x 4 m grid spacing between control joints was used for the hydrophobic concrete floor area (Fig. 2, south of Line M2), and a 8 x 8 m grid spacing was used for the normal concrete floor area (Fig. 2, north of Line M2). Each of the two interior ramps was built using a continuous placement of hydrophobic concrete. Thus, three floor designs are being compared in this study: (i) hydrophobic concrete slab with a 4 x 4 m control joint spacing; (ii) hydrophobic concrete ramps with no control joint, and (iii) normal concrete slab with a 8 x 8 m joint spacing and a polymeric membrane.

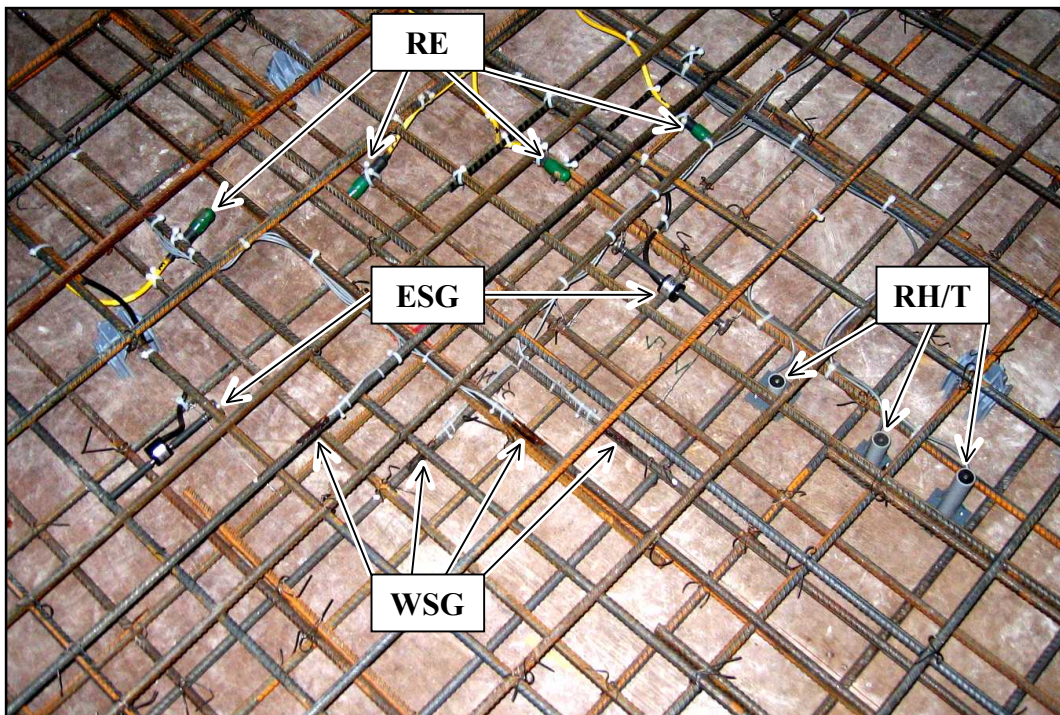
Figure 3: Typical instrumented section before placement of concrete

Over 100 sensors were installed in the parking structure. As shown in Fig. 3, each instrumented section includes: (i) three relative humidity and temperature (RH/T) sensors installed in the concrete at different depths to measure drying and temperature profiles; (ii) two embedment strain gauges (ESG) placed in concrete at mid-depth in both directions to measure drying shrinkage and detect cracks; (iii) four 10M 2-m long reinforcing steel bars, each instrumented with two weldable strain gauges (WSG), attached to the top and bottom rebar layers in both directions; and (iv) four manganese dioxide reference electrodes (RE) installed at the top and bottom layers of reinforcement to monitor their corrosion potential.
